Manhole Inspection Summary

Manhole # S27A__050MH

Insp Date: **4/16/09 2:56 PM**

Location Address: **1013 MYRTLE AVE**

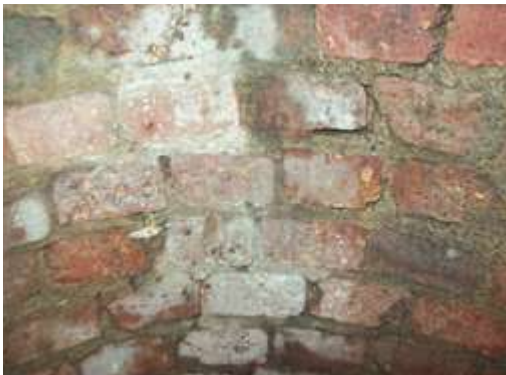
Defect 3

Infiltration: ☐ None ☐ Joint ☐ Cracks ☐ Mortar ☐ Roots ☒ **Wall**

INFILTRATION ON BARREL

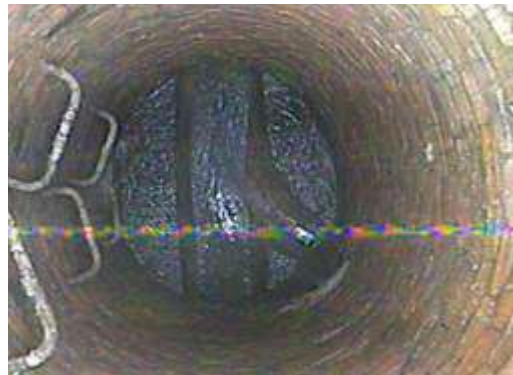
Defect 2

Count: **7** Missing: **0** ☒ **Corroded**

CORRODED STEPS

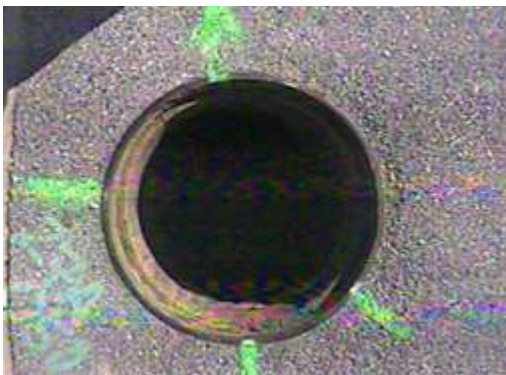
Defect 1

Offset: **1** (in.)

FRAME OFFSET

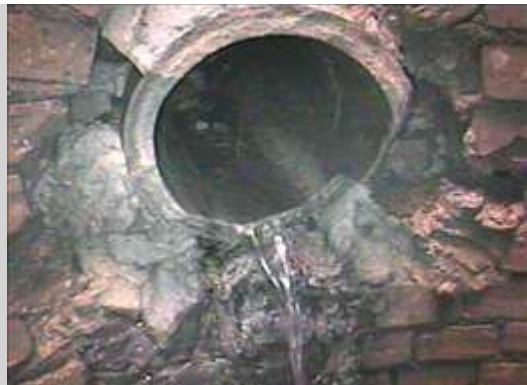
5 O'Clock Inflow

Pipe Height: (in.) Direct
Pipe Material: **Clay** ☐ Pipe Lined
Invert Depth: **9.28** (ft.) Flow Characteristics: **Slow**
Deposits: ☐ None ☐ Mud ☐ Sludge ☒ **Debris** ☐ Grease
Silt Depth: **1** (in.) Deposits Extent: **Light**
Infiltration: **None** Pipe Seal Cond: **Sound**

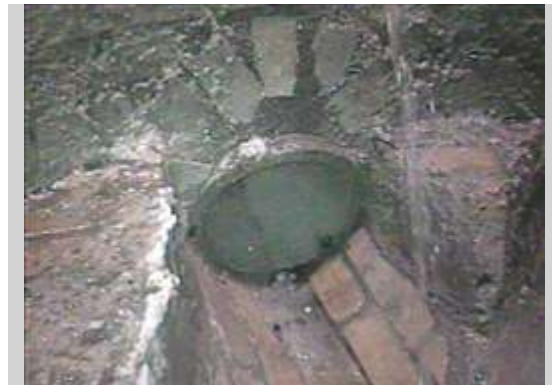
Drop In @ 5 O'Clock

Drop: **Outside Direct**
Angled: Reading: (ft.)
Inv Depth: **12.56** (ft.)
Drop Condition: **Partly Clogged**
